Phase I Environmental Site Assessment

Broadway at Center South Broadway Avenue and East Center Street Rochester, Minnesota

Titan Development and Investments

Project RO-13-08144A February 10, 2014

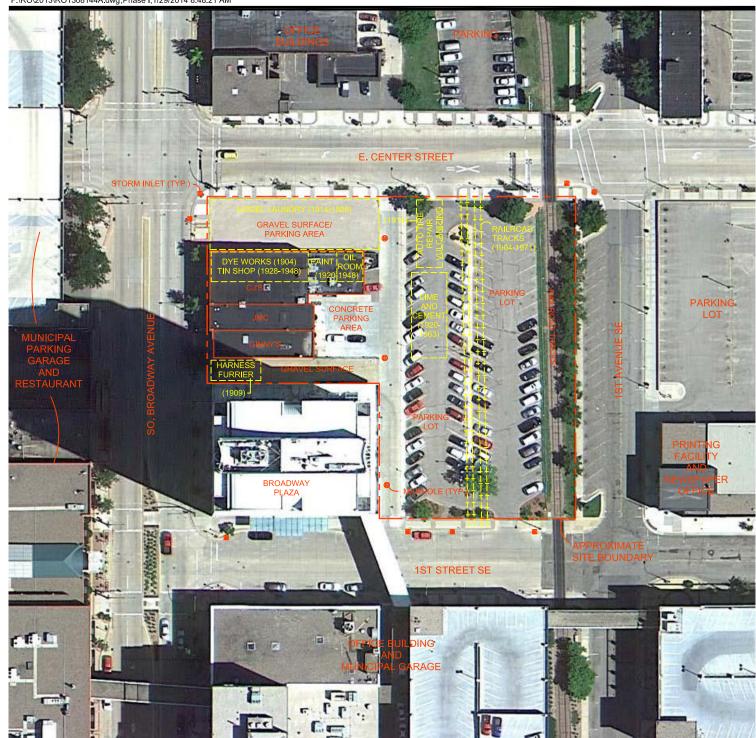
Site Sketch

NOTE: FORMER STRUCTURES AND FEATURES, SHOWN IN YELLOW, ARE APPROXIMATED FOR GRAPHICAL PURPOSES ONLY

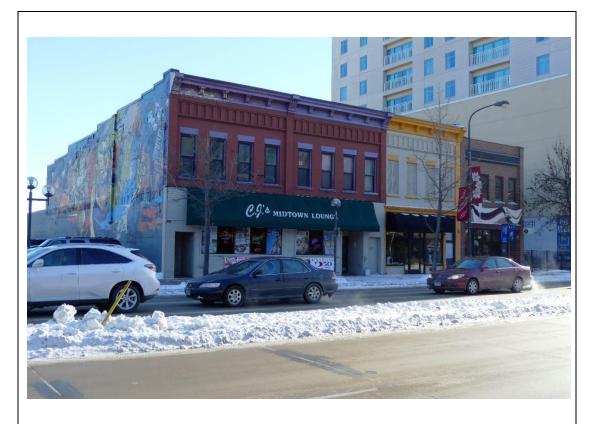
Photograph #1	Broadway at Center	RO-13-08144A
Date:	January 23, 2014	
Direction:	Facing East	BRAUN
Subject:	Subject Property – CJ's Bar, Jacobson Management	INTERTEC
	& Ginny's Fine Fabrics

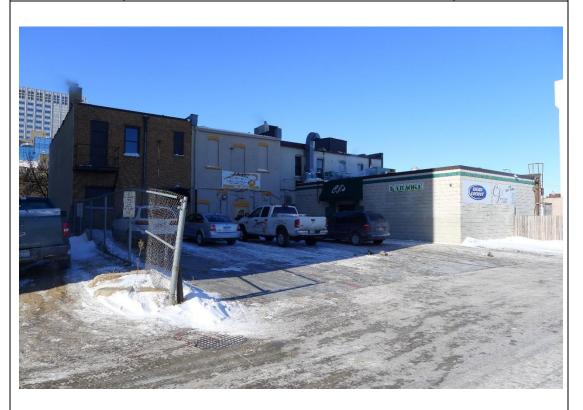
Photograph #2	Broadway at Center	RO-13-08144A
Date:	January 23, 2014	BRAUN
Direction:	Facing West	
Subject:	Subject Property – Rear View of the Three Structures	INTERTEC

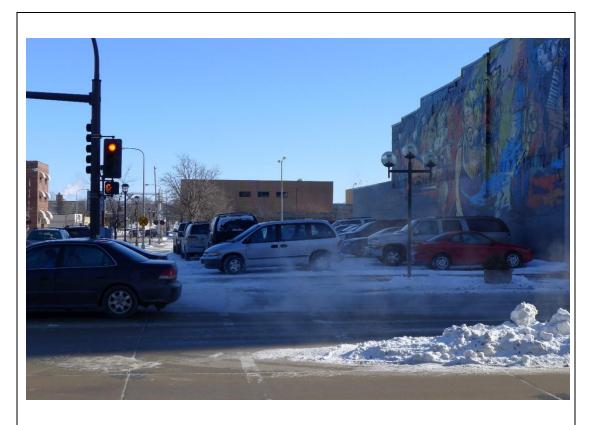
Photograph #3	Broadway at Center	RO-13-08144A
Date:	January 23, 2014	BRAUN
Direction:	Facing East	
Subject:	Subject Property, Vacant Lot on South Broadway	INTERTEC

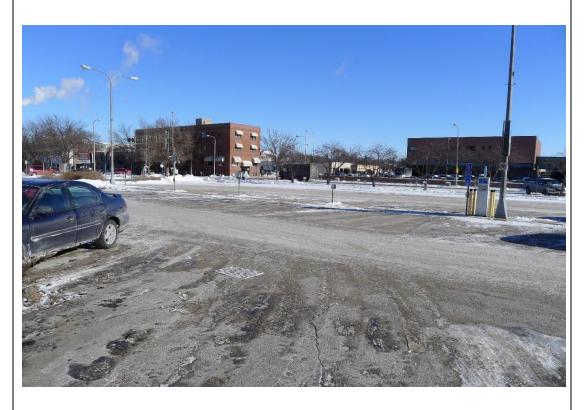
Photograph #4	Broadway at Center	RO-13-08144A
Date:	January 23, 2014	BRAUN
Direction:	Facing East	
Subject:	Subject Property – City Owned Parking Lot	INTERTEC

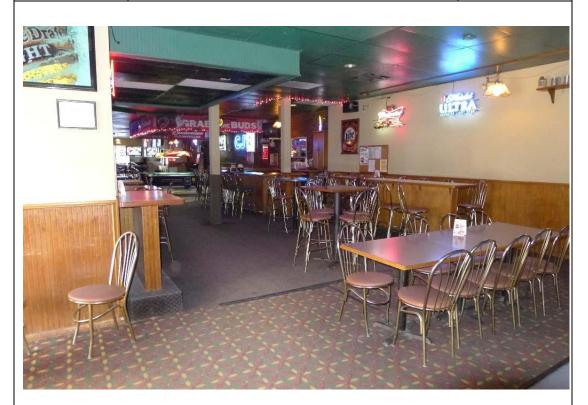
Photograph #10	Broadway at Center	RO-13-08144A
Date:	January 23, 2014	BRAUN
Location:	Interior – CJ's Bar	
Subject:	Bar Main Floor	INTERTEC

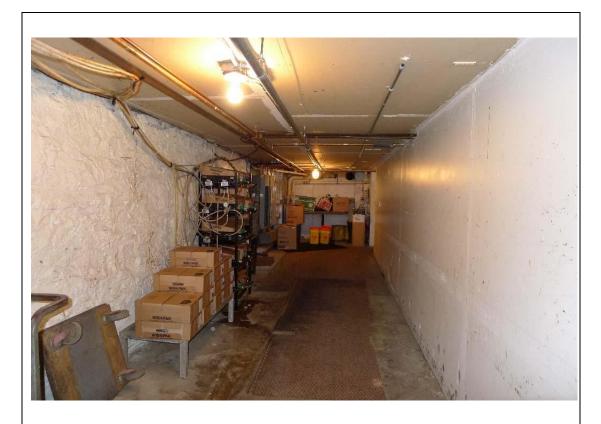
Photograph #11	Broadway at Center	RO-13-08144A
Date:	January 23, 2014	BRAUN
Location:	Interior – CJ's Bar	
Subject:	Basement Storage Area	INTERTEC

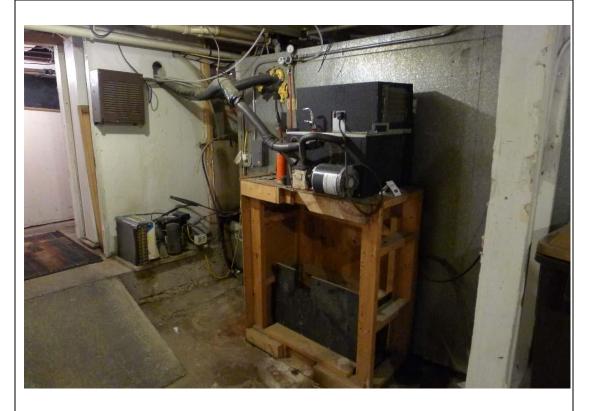
At least four compressors were observed in the basement of the CJ's Bar property, serving walk-in cooling units.

Photograph #12	Broadway at Center	RO-13-08144A
Date:	January 23, 2014	BRAUN
Location:	Interior – CJ's Bar	
Subject:	Basement Cooler Compressors	INTERTEC

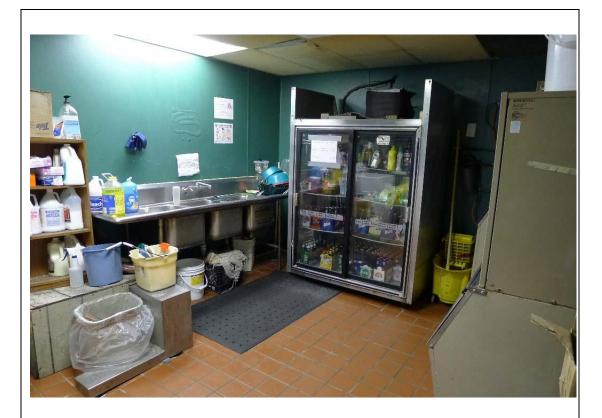
Photograph #13	Broadway at Center	RO-13-08144A
Date:	January 23, 2014	BRAUN
Location:	Interior – CJ's Bar	
Subject:	Main Floor Food Preparation and Laundry Room	INTERTEC

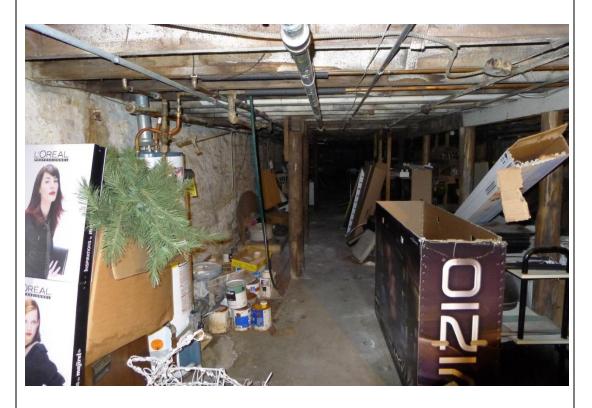
No drums containing unidentified substances suspected of being a hazardous substance or petroleum product were observed at the Site at the time of our reconnaissance. An empty 55-gallon drum of unknown former contents was observed in the basement of the Jacobson Management Company.

Photograph #18	Broadway at Center	RO-13-08144A
Date:	January 23, 2014	BRAUN
Location:	Interior – Jacobson Management	
Subject:	Basement Storage Area	INTERTEC

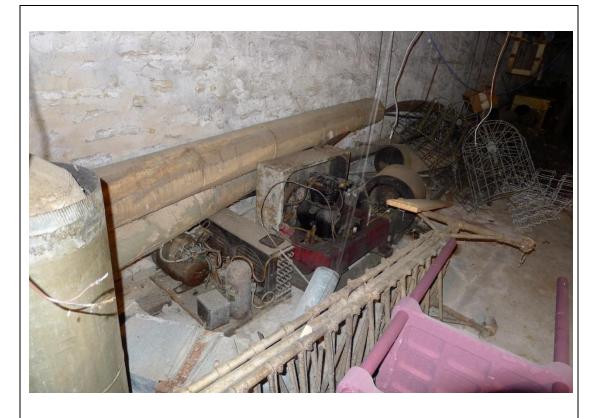
Five compressors that are not being used were observed in the basement of the Jacobson Management Company. The compressors appear to have been left from previous tenants.

Photograph #19	Broadway at Center	RO-13-08144A
Date:	January 23, 2014	BRAUN
Location:	Interior – Jacobson Management	
Subject:	Basement Storage Area (Compressors)	INTERTEC

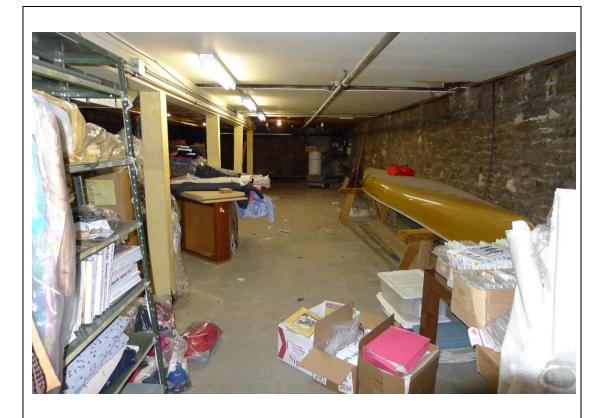
Photograph #21	Broadway at Center	RO-13-08144A
Date:	January 23, 2014	BRAUN
Location:	Interior – Ginny's Fine Fabrics	
Subject:	Basement Storage Area	INTERTEC

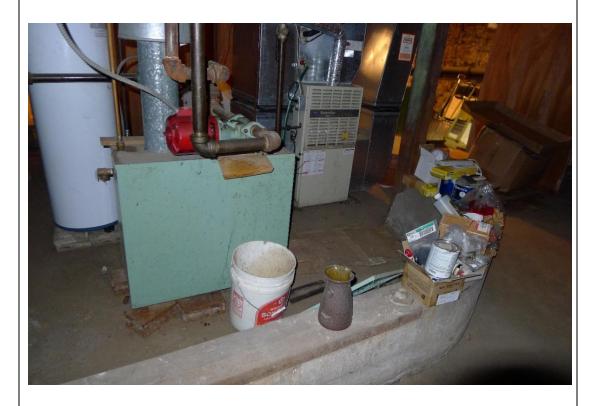
Photograph #22	Broadway at Center	RO-13-08144A
Date:	January 23, 2014	BRAUN
Location:	Interior – Ginny's Fine Fabrics	
Subject:	Basement Utility Area	INTERTEC
